Confidential Inspection Report

Inspection site:
3456 Anyplace
Somewhere, MI 34567

Prepared by: Solid Rock Inspections
46498 Houghton Dr.
Shelby Twp., MI 48315
866 808 4814 info@solidrockinspections.com

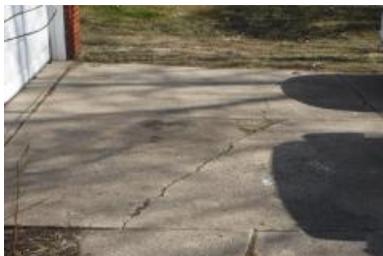
Driveway:

Drive material, Concrete, Cracks noted are typical.

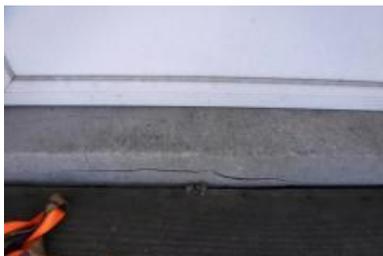
**Exterior Steps /
Stoops:**

Sills at back door and front window are cracked and will need to be replaced.

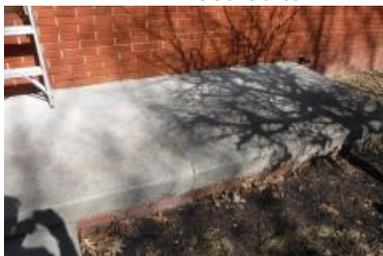
Slab:

Cap material is: Concrete. Slab is cracked down the middle. Ensure it stays sealed to minimize water entry which speeds up the process of the cap failing.

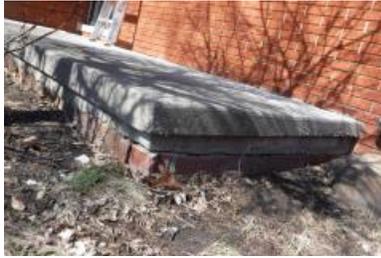
Structure:

- Type: Brick cracked and shifting. Recommend repairing or replacing.

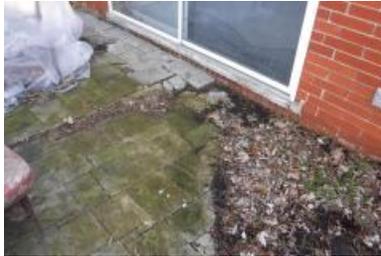
Condition:

- Type: Patio Blocks are laid overtop an existing concrete patio. Blocks have shifted and settled. It may be that the concrete has settled which have in turn caused the blocks to drop along with them. It may be necessary to remove all materials and start fresh. Then reset the block. Recommend resetting to minimize the chances of a trip hazard.

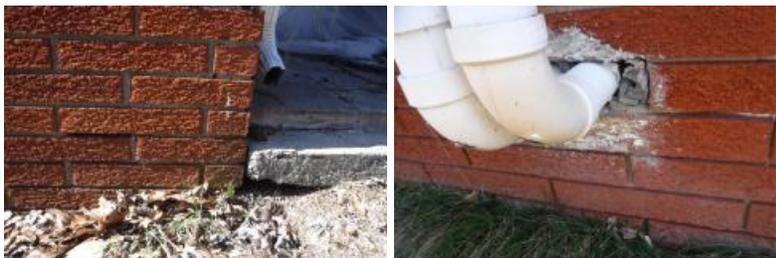
Materials & Condition:

- Walls are constructed with: Brick. Slight shifting has occurred at the south west corner. monitor and make any necessary corrections. Continue to ensure the the condition doesn't worsen. Also keep the downspouts properly extended from the building. Replace missing mortar where the furnace flue pipes exit the building. Replace missing mortar where the furnace flue pipes exit the building.
- Replace missing mortar where the furnace flue pipes exit the building.

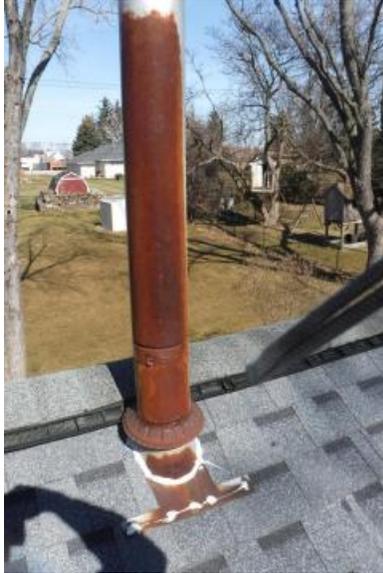
Chimney Exterior:

- Brick materials. Metal chimney goes to the old furnace located in the attic. The furnace is non functional. Recommend removing this and shingling over.

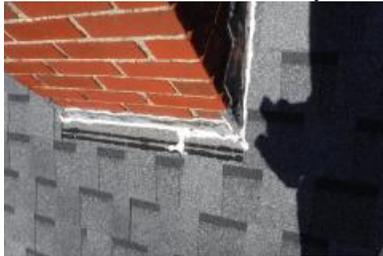
Flashing:

- Flashing is improperly done. Recommend correcting to minimize chances of water entry. No apron flashing is present.

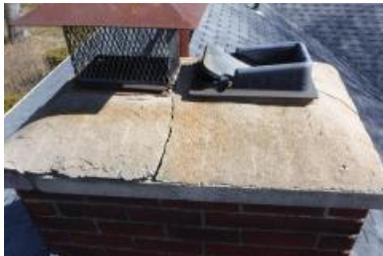
Chimney Cap:

- Masonry chimney cap is cracked and loose. Sections can be easily lifted off. This will allow water entry. Top mount damper is not functioning properly. Recommend correcting.

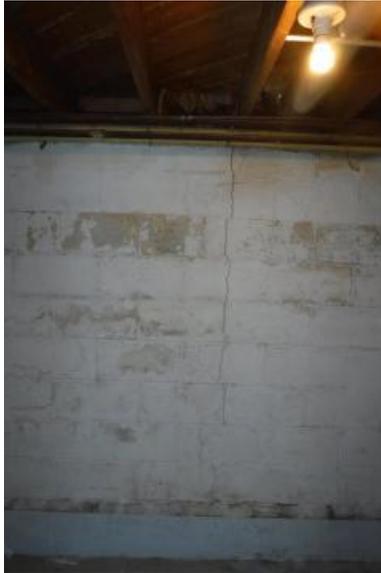
Walls:

- Walls are concrete block. Some vertical and horizontal cracks were noted. Monitor and make any necessary corrections in the future. Basement has a waterproofing system installed. Cleanouts are located to inspect and ensure water is flowing properly and no debris is in the system.

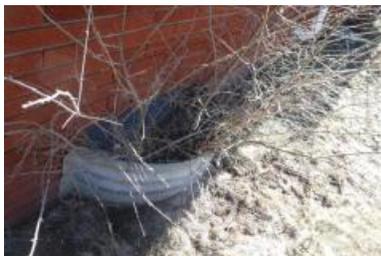
Windows:

- Metal framed, The installed windows are below grade, but they are installed in wells that should minimize the probability of water leakage. Remove several trees from seedlings in the window wells.

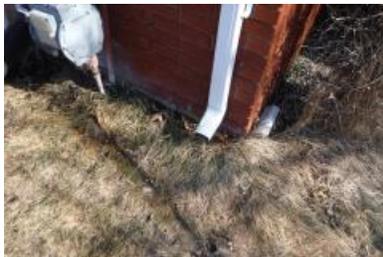
Gutters & Downspouts:

Gutter material is: Aluminum, Route downspouts away from the building

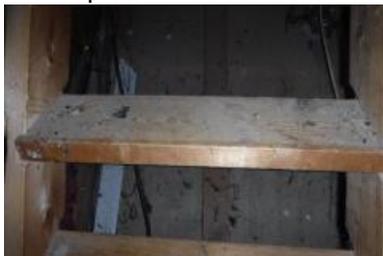
Access:

Walk up attic access located between the dining and family rooms. One of the steps is loose.

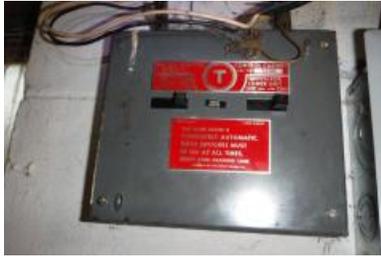
Basement. Suggest getting rid of the electric water heater panel which is wired directly into the meter and wire into the main panel.

Breakers, Main is 200 Amp.

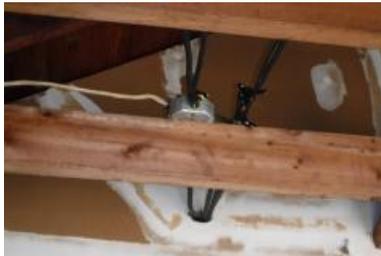
Garage Walls:

Junction box cover(s) are missing. Improper wiring noted in the attic area. (Ceiling is open so this can be seen from below.) Recommend correcting immediately to minimize chances of an electrical fire.

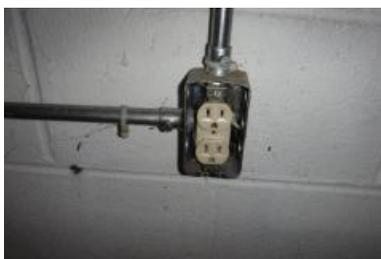
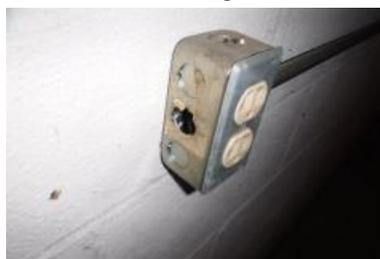
General:

There are several outlets missing covers.

at least one was noted to be missing a knockout.

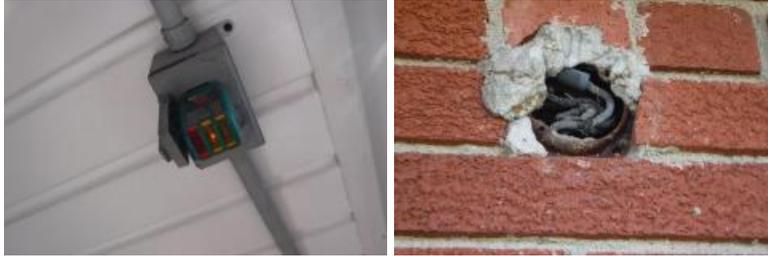
Exterior Walls:

Replace existing outlets with GFCI protected outlets. Open ground. Former light fixture at the rear swing door off the dining room fell off onto the ground and wiring is exposed. Recommend correcting.

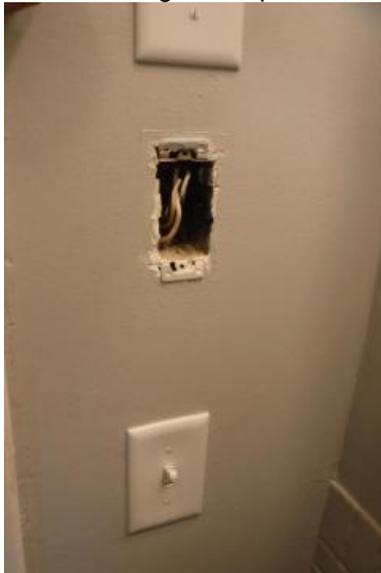
Powder Room

Outlet missing and exposed wiring.

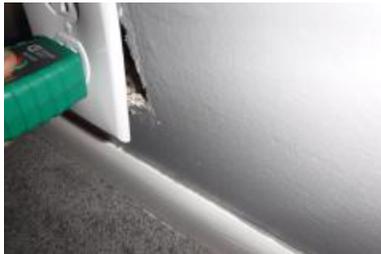
Dining Room:

Outlet box is not fastened to the stud or drywall.

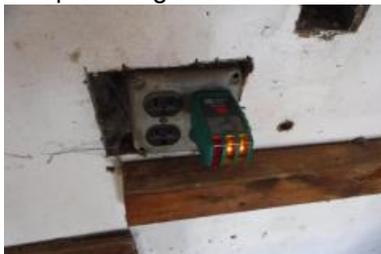
Garage Walls:

Swap existing outlet with a GFCI protected outlet for safety.

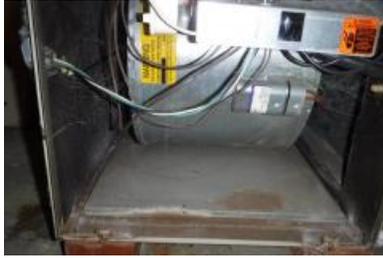
Cabinet:

Unit functioned properly at the time of the inspection. There are some stains and minor corrosion in the unit. Abnormal sound takes place at start up. Have the unit inspected by a qualified licensed HVAC contractor to ensure proper operation and longevity.

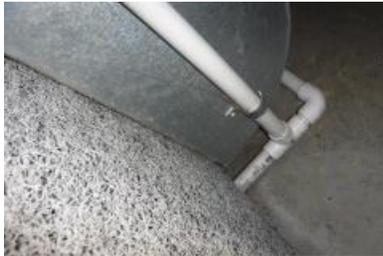
Air Filters:

25 x 16 x 1. The filter is in need of replacement.

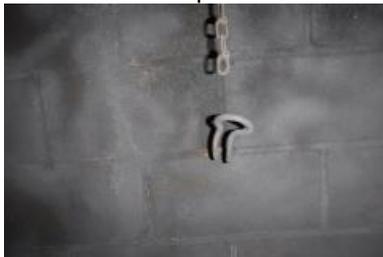
Living Room:

Masonry fireplace. As noted before the top mount damper is in operable. Main original damper appears to be functioning properly but needs the chain to be extended and a small handle installed to lock in place to use. Lots of Creosote present. Clean before use.

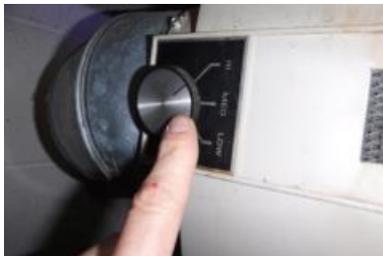
Humidifier

Damper is not functioning properly. It is not possible to get to the closed position which is where it needs to be in the summer in order to run the most efficient when running the AC.

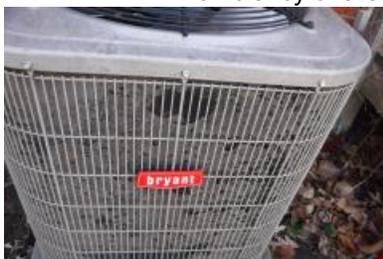
System Condition:

- Exterior needs to be cleaned. Lots of debris around the coil which will lower the efficiency of the unit.

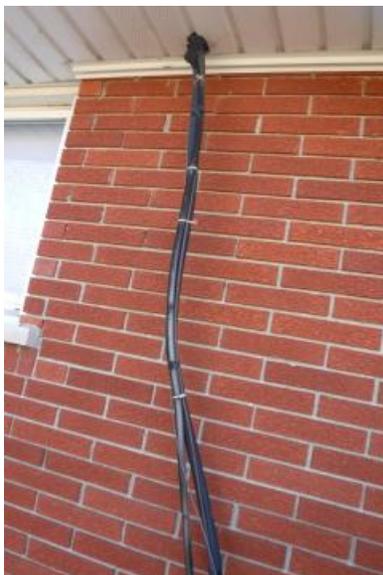
Condensate Line:

- Old line has been left and abandoned.

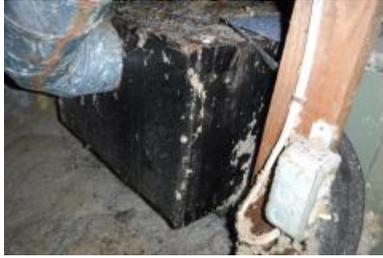
- Family doesn't appear to have any return ductwork and old ceiling vents do not appear to be used anymore. Unknown where the attic system would be

connected to the basement. Besides it would be improperly balanced to do so.

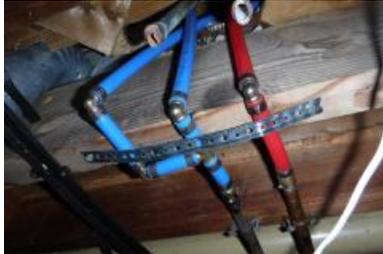
Condition:

- The lines are improperly sized for the main bath.

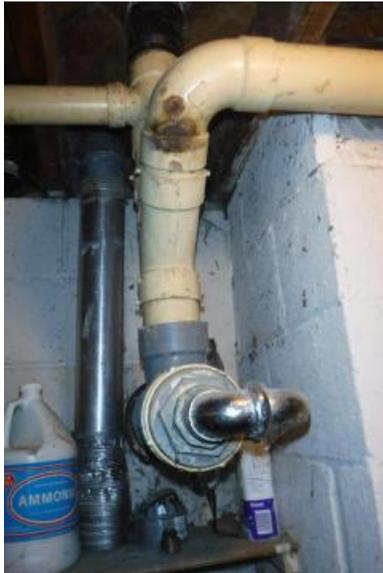
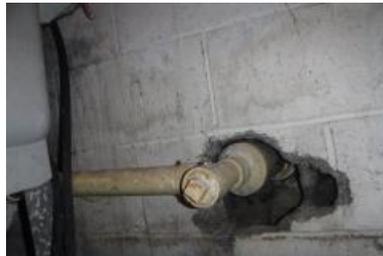
Condition:

- It appears as though the house was replumbed when connected to the sewer years ago.
 Laundry tub most likely connects to the sewer line out in the yard as the Shellback upflow pump is gone.

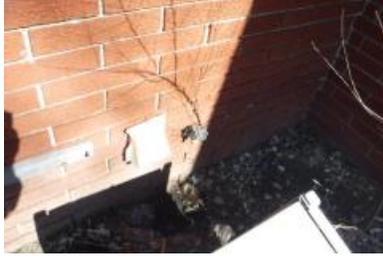
General:

- These are connected to the former well but no pressure was noted and pressure tank is in pretty bad shape. Suggest removing and replumbing hose bibs to the Municipal water.

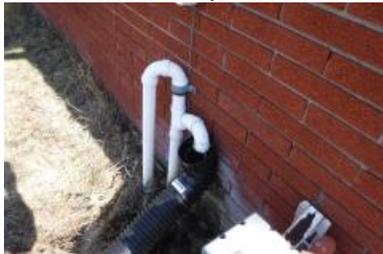
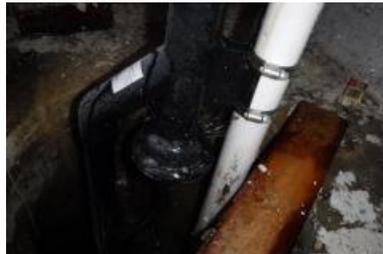
Basement:

Sump pump is functioning properly in the pit but the discharge is plugged and has been for quite some time noted by heavy staining and a downspout taking the water away from the house as it dumps out of the vent/overflow.
 There is a backup system installed but it is none functioning as the casing is split on it.

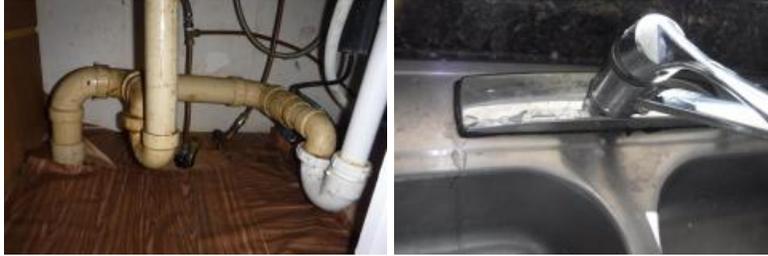
Kitchen faucet is leaking.

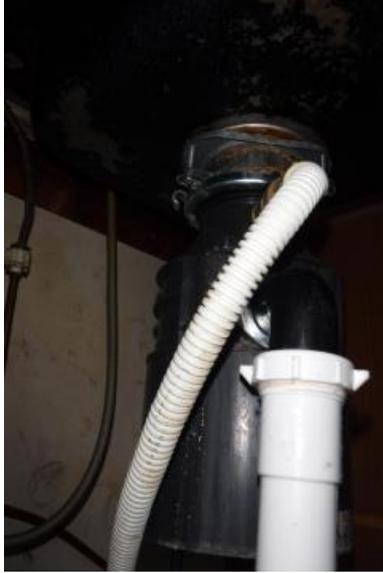
Condition:

Leaking at the disposal.

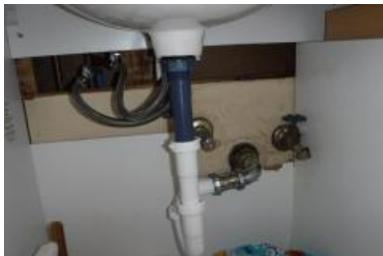
Main Bath:

Leaking at the drain.

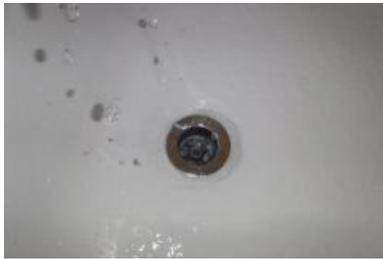
Main Bath:

Stopper not present.

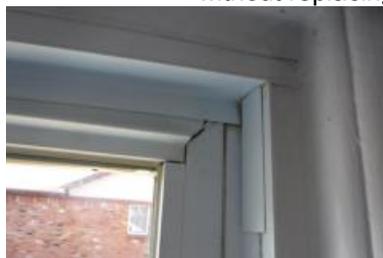
General Type & Condition:

- Windows are vinyl double pane insulated glass. All functioned properly with the exception of one of the bedroom windows where the case is split. Feel free to contact either Independent window repair at 586 749 4449 or R and R window repair at 734 326 2657 to see if they might be able to help repair the window without replacing.

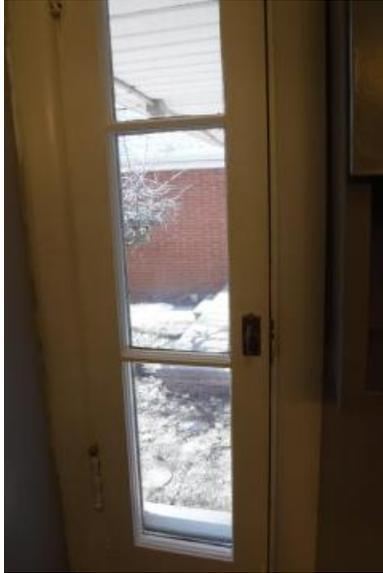
Powder Room

Unable to open as it is painted shut.

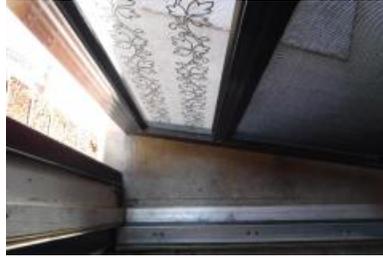
Entry

Steel Entry, Aluminum Storm missing a closer and it scrapes the threshold.

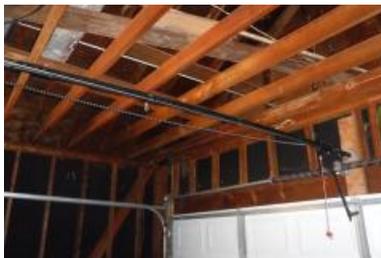
Door Operator:

Door opener chain tension needs adjustment to insure safe conditions.
